## Designing for Maintainability: Maintenance Considerations in Sustainable High-Rise Office Design in Tropical Nigeria

**Keywords:** Maintenance Design, High-Rise Office Buildings, Building Maintainability, Architectural Design Integration, Sustainable Building Practices

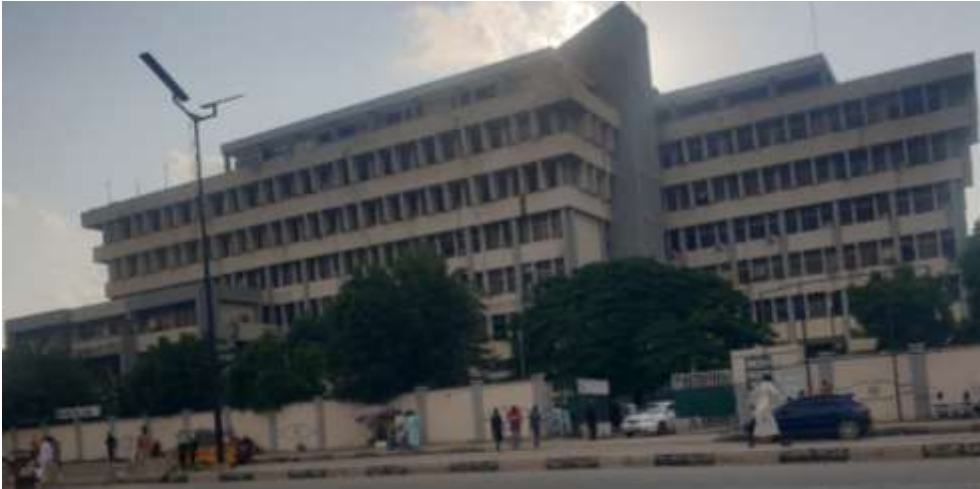
Maintenance access is also poor, as presented in Figure 1. While internal staircases provide roof access, there is no safe provision for maintaining the building's exterior without costly external equipment such as dumpers, ladder trucks or a complex network of scaffolding. According to Wai (2024), the Chartered Institution of Building Services Engineers (CIBSE) advocates for accessible design to ensure regular, low-disruption maintenance, which Gidan Murtala fails to provide. Additionally, strategic features like modular design or durable finishes, which Pitt and Tucker (2008) suggest for affordable upkeep, are absent.

Figure 1: No Safe Provision for Maintaining the Building's External Components at Gidan Murtala Complex, Kano

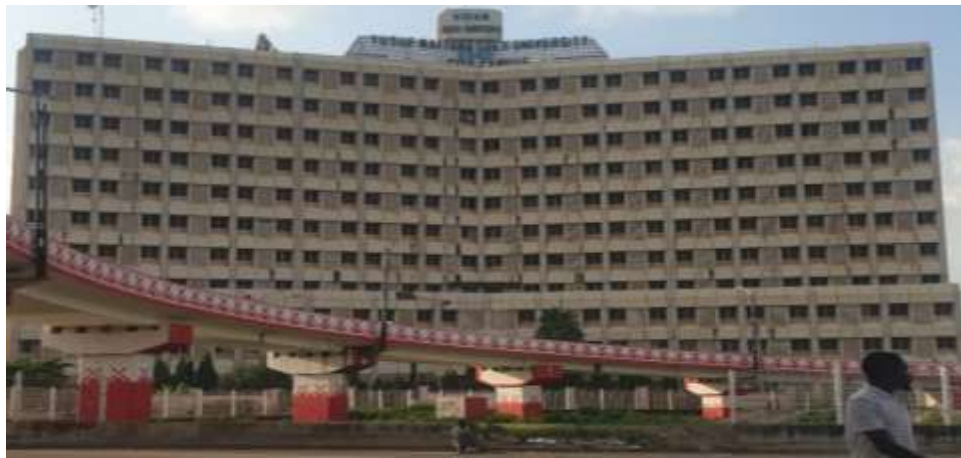
Material choices further compound the challenges, as presented in Figure 2. While reinforced concrete and precast shading elements are robust, reliance on painted walls and poor-quality glazing exposed the building to rapid deterioration. In Kano's climate, material durability against UV radiation and dust is essential. As Olanrewaju and Abdul-Aziz (2015) emphasise, inappropriate materials drive up maintenance needs and costs. More durable coatings and high-performance glazing, as recommended by Straube and Burnett (2005), would have reduced upkeep requirements significantly. Though lifts and staircases allow roof access, no external maintenance systems exist, contradicting principles of "designing for maintenance" (Chanter & Swallow, 2007). Without easy exterior access, routine upkeep becomes difficult, leading to deferred maintenance and expensive repairs.

Figure 2: Massive painted walls and poor-quality glazing expose the building to deterioration at Gidan Ado Bayero Complex, Kano

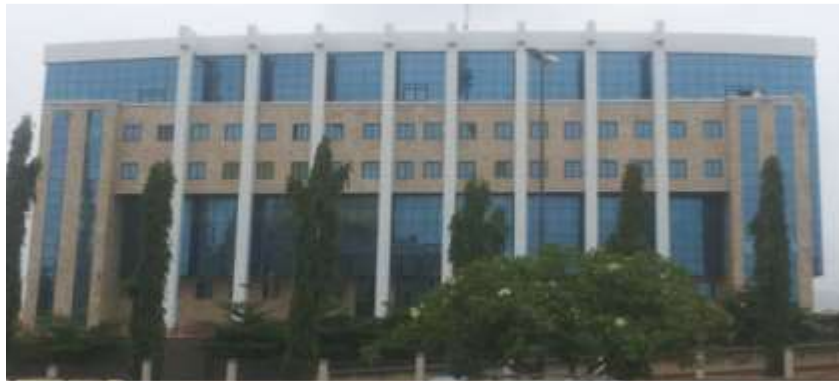
Internal vertical mobility through lifts and staircases is sufficient, but crucially, no dedicated external maintenance systems—such as gondola rails or fixed scaffolding supports—were incorporated. Modern practices (Shohet, 2003) recommend facade maintenance technologies for safety and efficiency, and their absence increases reliance on risky, costly external equipment. Environmental considerations were partially addressed through a north-south building orientation, mitigating east-west solar heat gain (Olgyay, 2015). However, external finishes, particularly marble cladding, remain vulnerable to pollution and weathering, necessitating frequent maintenance.

As presented in Figure 3, the omission of permanent maintenance technologies reflects a broader trend of sidelining facility management during the design phase. In contrast, scholars emphasise that embedding maintenance strategies early is crucial for sustainable building performance (Olawuyi et al., 2022; Lavy & Shohet, 2007). While space provision for external equipment is a minor positive, fully integrated systems like Building Maintenance Units (BMUs) would have demonstrated more profound lifecycle management foresight. In brief, the PPPRA Complex shows progress but underscores the need for stronger integration of maintenance design in Nigeria's evolving office architecture.

Figure 3: Durable Materials, Good Form and Orientation, No External Maintenance Systems at Petroleum Products Pricing Regulatory Agency (PPRA), Abuja
